# Beleuchtung Audi Concert II in Modell ohne CAN-Bus

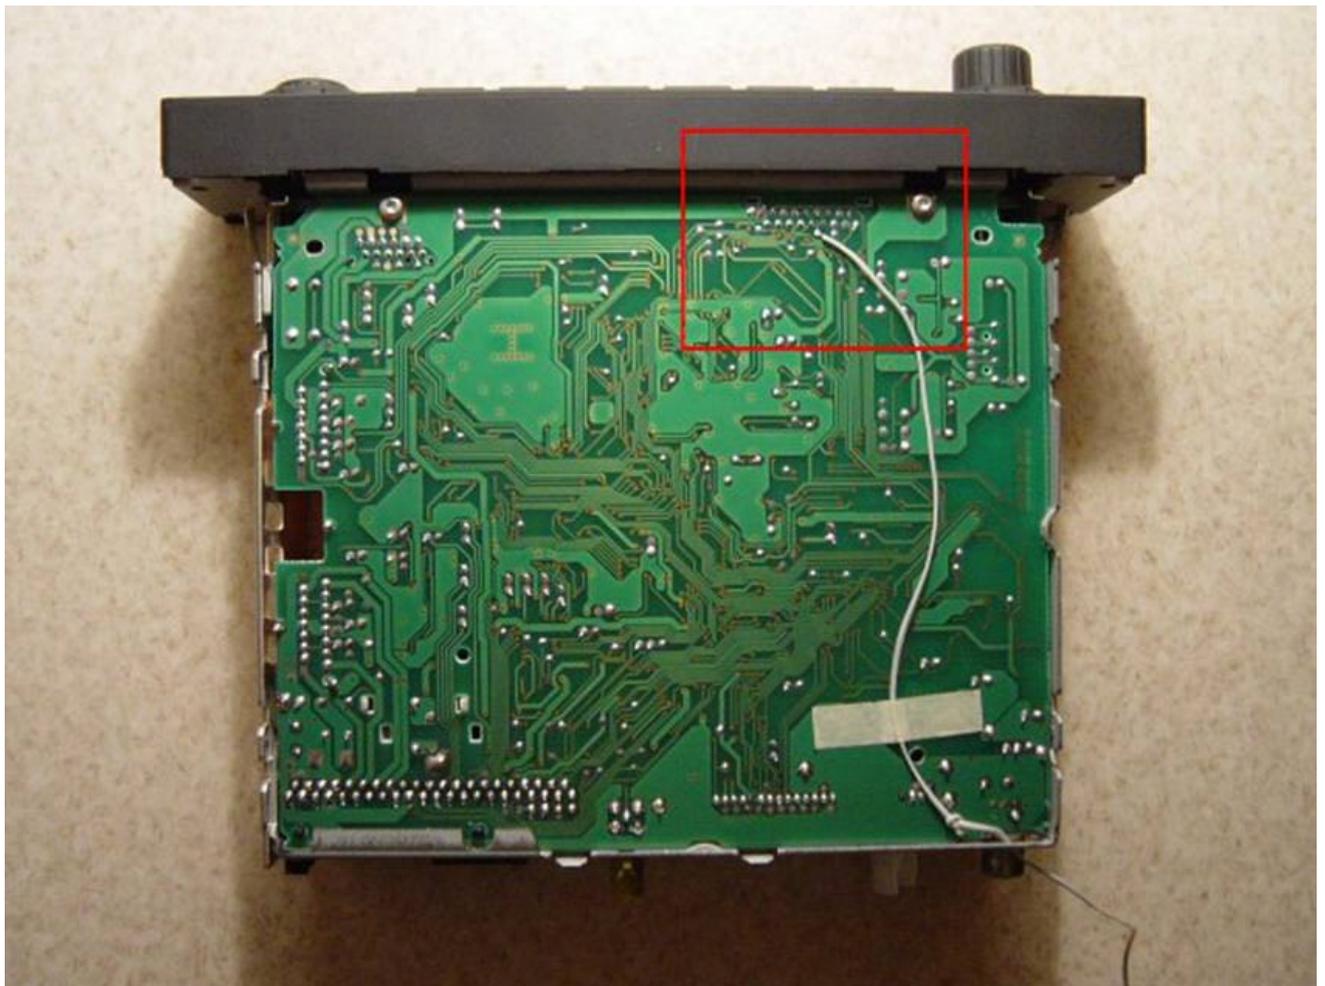
1. Prise open the under side cover from the unit using eg. a small screwdriver.
2. Locate the 18-pin connector area on the main PCB (See picture)

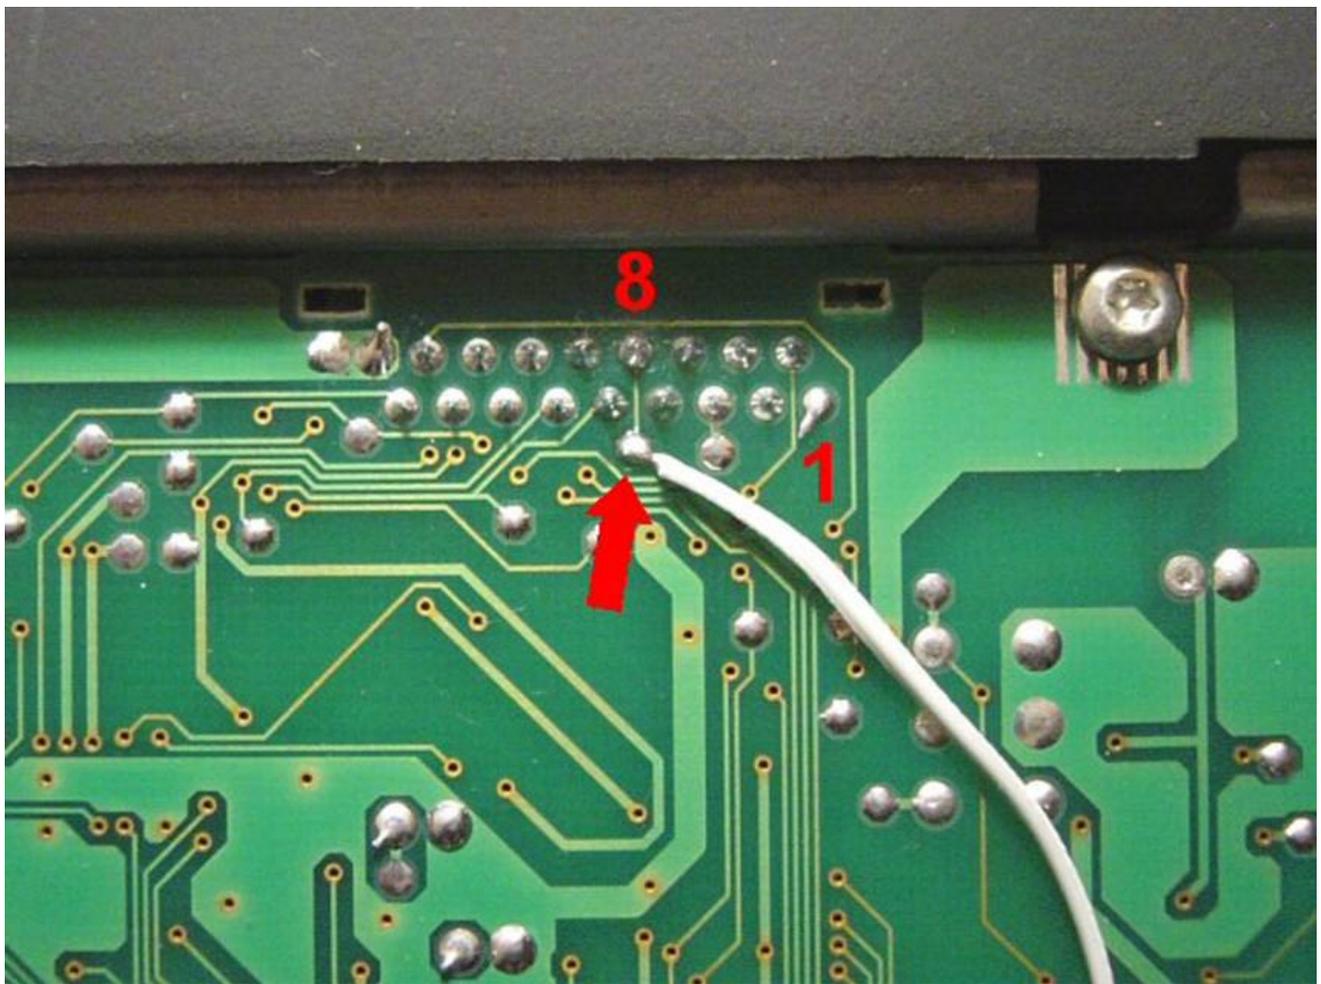
3. Counting from right, pin number 8 is the pin for illuminating the interface controls. It's in the row closer to the edge of the PCB.

4. Solder a 2ft long wire directly to pin 8 or to the tab located directly below it and connected to pin 8 (as in the picture).  
I found the tab to be the better option of the two because there's more room around it and less chance of short circuiting anything.. :-)  
I also think it's a good idea to let the wire run to the right from the tab, again for the reasons mentioned above.  
Also try to peel off as little isolation from the wire as possible before soldering.
